Manhole Inspection Summary

Manhole # S19GG2008MH

Insp Date: **10/13/06 9:31 AM**

Location Address: **SMITH AVE**

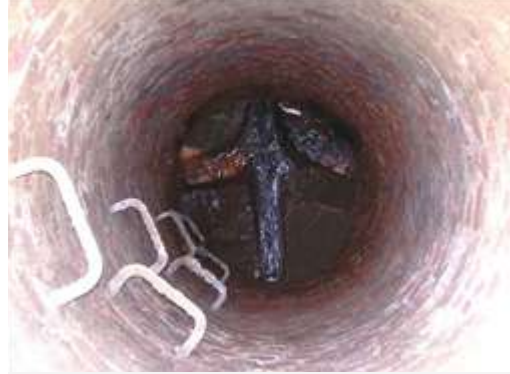
Top View

Corroded steps. Evidence of surcharge - Bench debris. Channel debris.

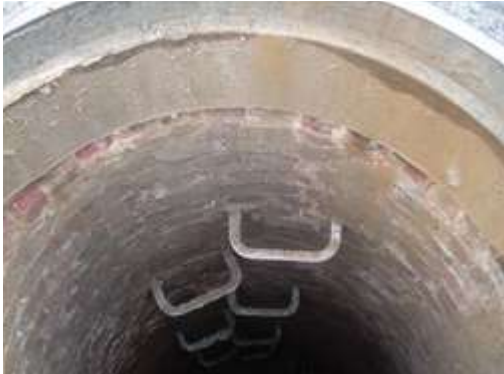
Defect

Frame leaks. Adjustment deterioration and infiltration. Barrel infiltration - other side.

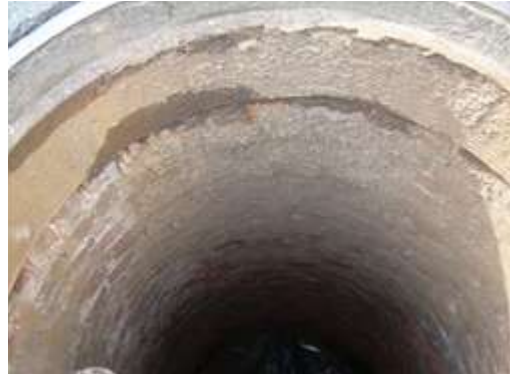
Defect

Frame leaks. Adjustment deterioration and infiltration. Barrel infiltration.

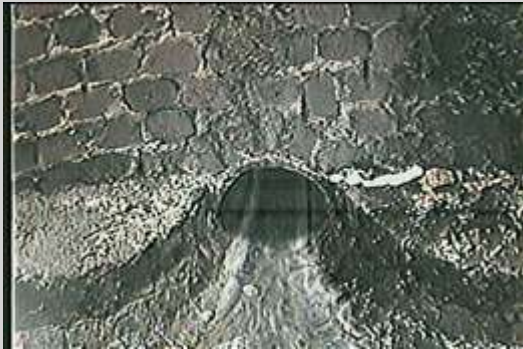
8 in. Circular Gravity Sewer Pipe Out @ 12 O'Clock

Barrel deterioration and infiltration. Channel deterioration.

Deposits: ☐ None ☐ Mud ☐ Sludge ☐ Debris ☒ **Grease**

Infiltration: **Evidence** Pipe Seal Cond: **Unknown**

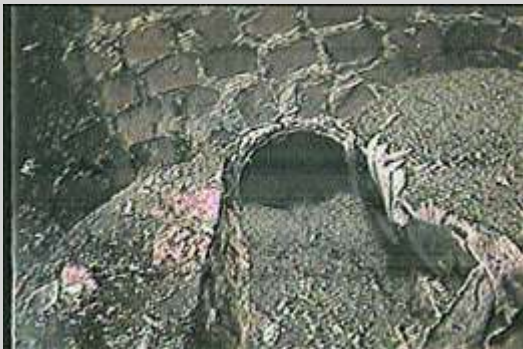
8 in. Circular Gravity Sewer Pipe In @ 3 O'Clock

Deposits: ☐ None ☒ **Mud** ☐ Sludge ☒ **Debris** ☐ **Grease**

Infiltration: **Evidence** Pipe Seal Cond: **Cracked**

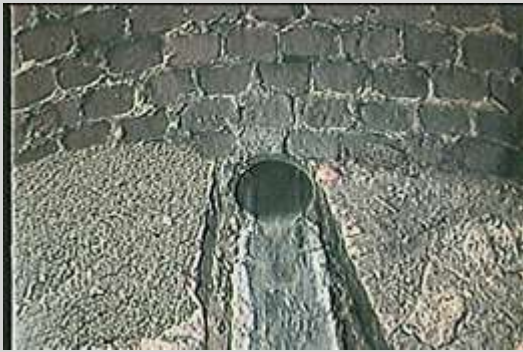
Pipe In @ 6 O'Clock

Channel deterioration.

Infiltration: **Evidence** Pipe Seal Cond: **Cracked**

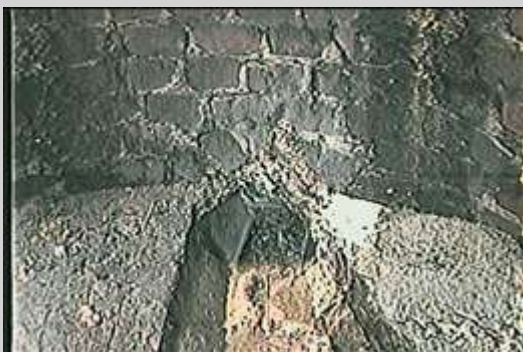
Pipe In @ 9 O'Clock

Deposits: ☐ None ☒ **Mud** ☐ Sludge ☒ **Debris** ☒ **Grease**

Infiltration: **Evidence** Pipe Seal Cond: **Broken**
